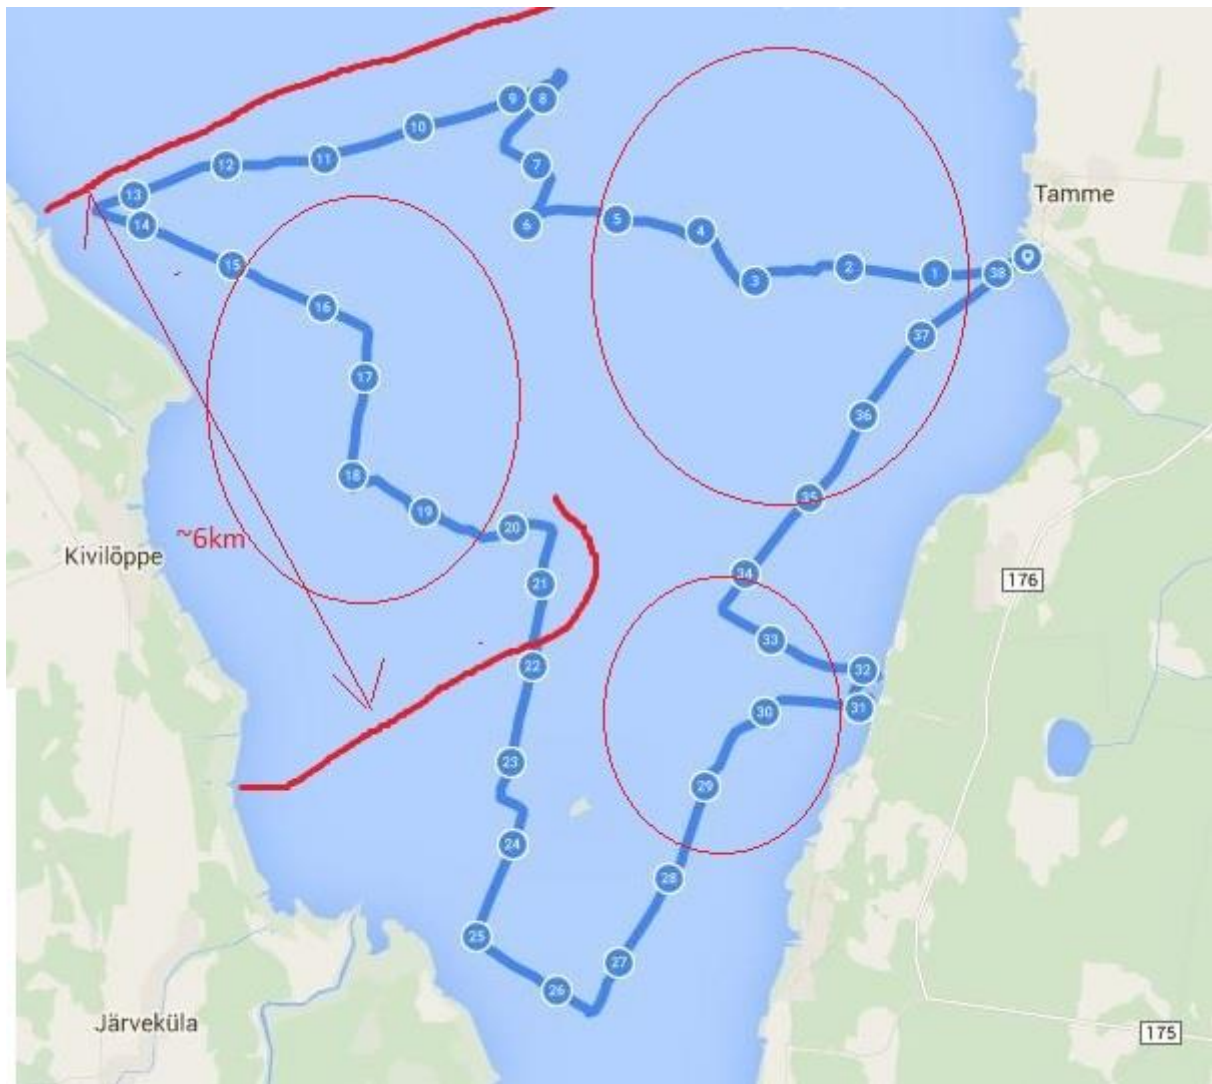
Northern crack (red line) runs across the lake and is about 1m wide. Southern crack runs to the middle of the lake and turns north, from there runs north about 1km, Crack is about 10-30cm wide.

Ice overall is hard and dry. At point 26 ice has no cracks but is a bit bumpier than in the north. Suitable race areas marked with red circles.

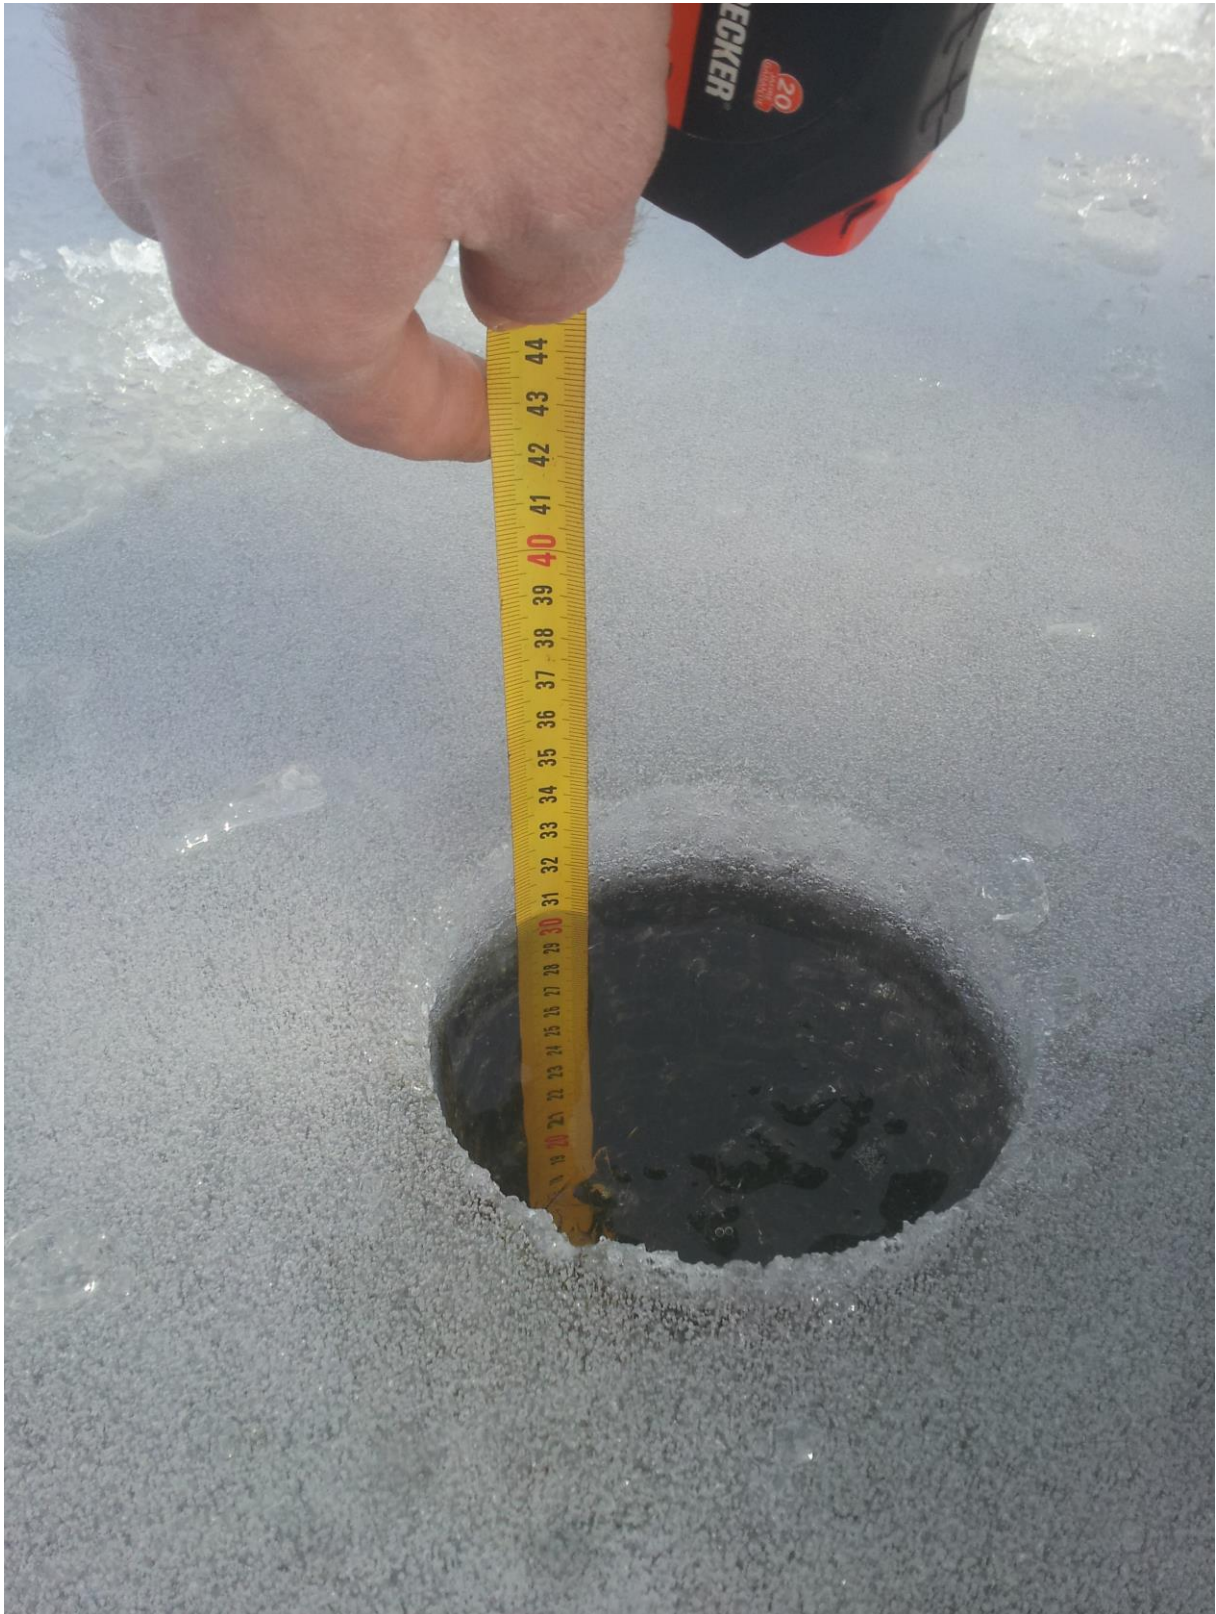
Point 1. Thickness 32cm

Pic 1. Ice thickness at point 1

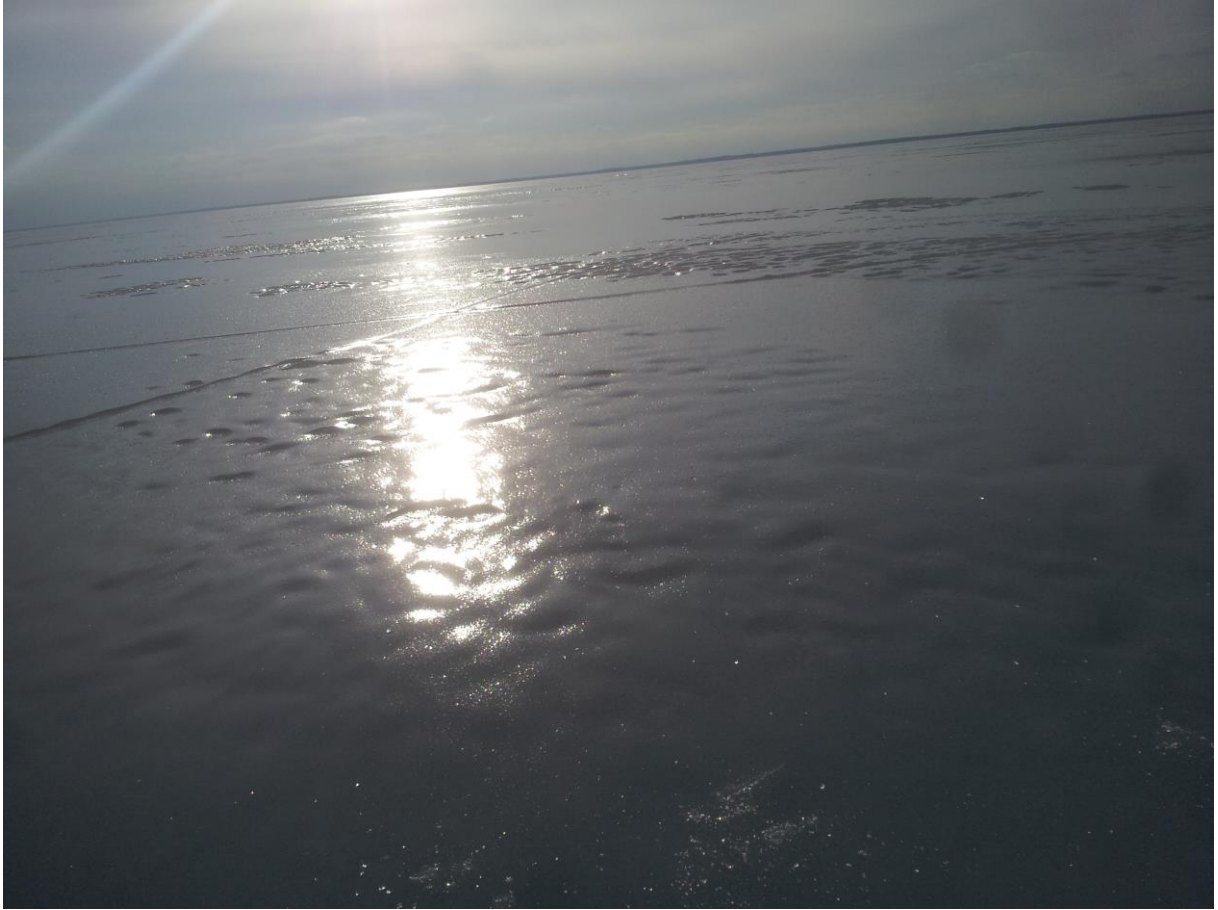
Pic 2. Ice overview at point 1

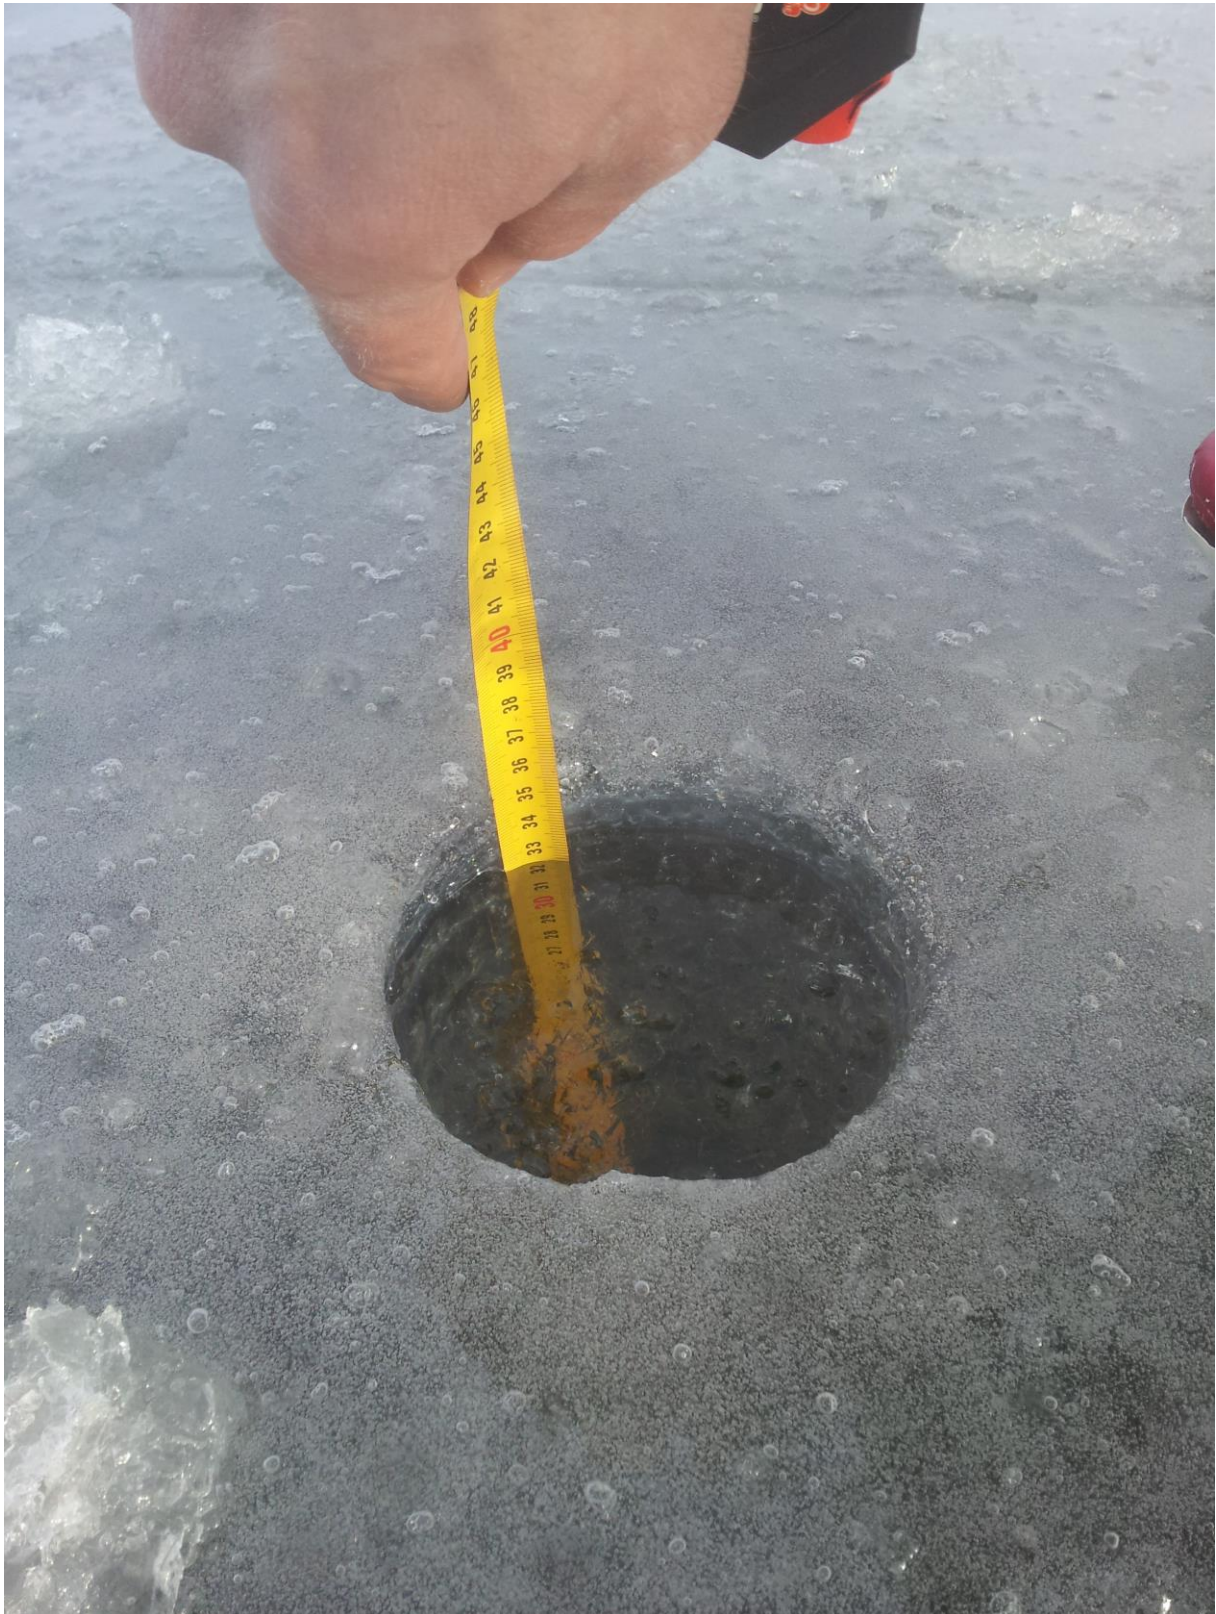
Point 3. thickness 35cm

Pic 3. Ice thickness at point 3

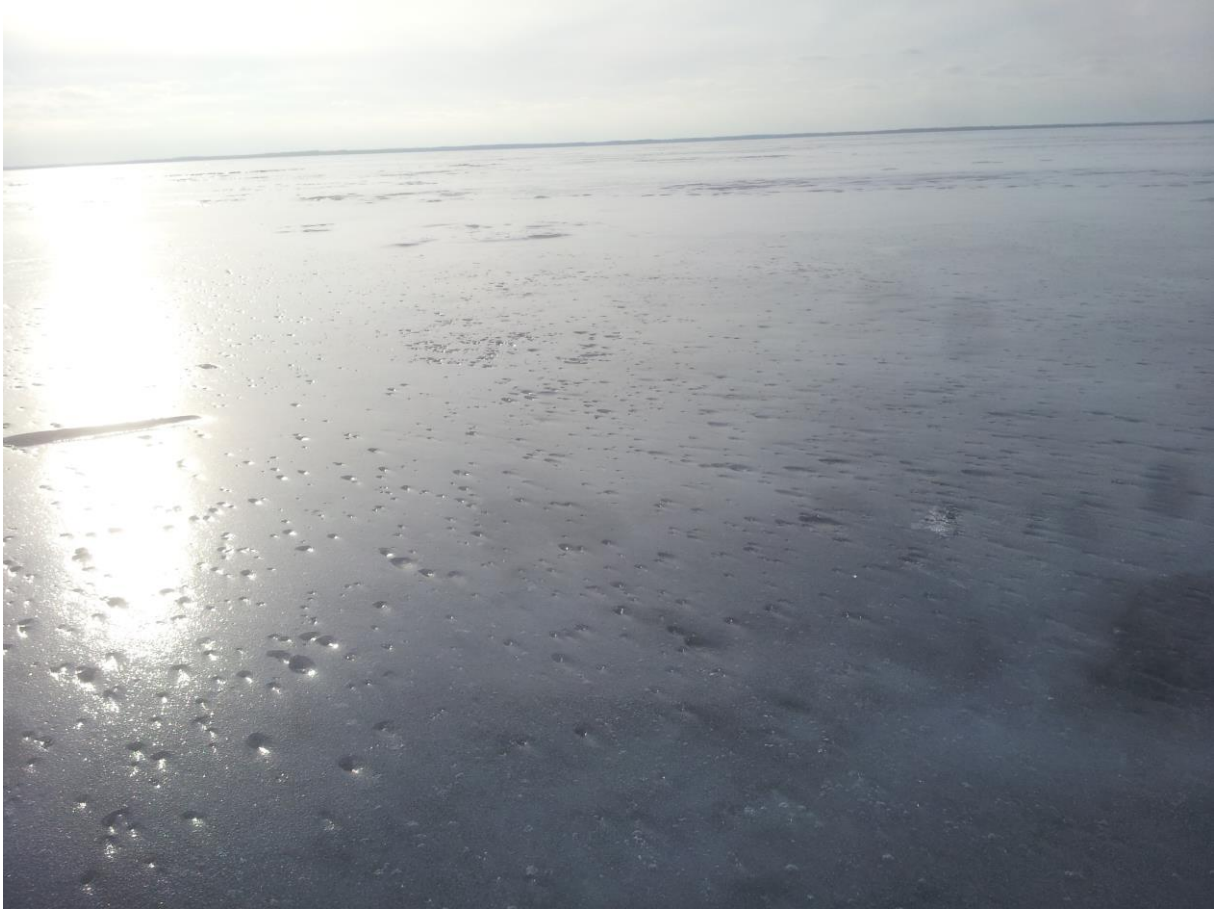
Pic 4. Ice overview at point 3.

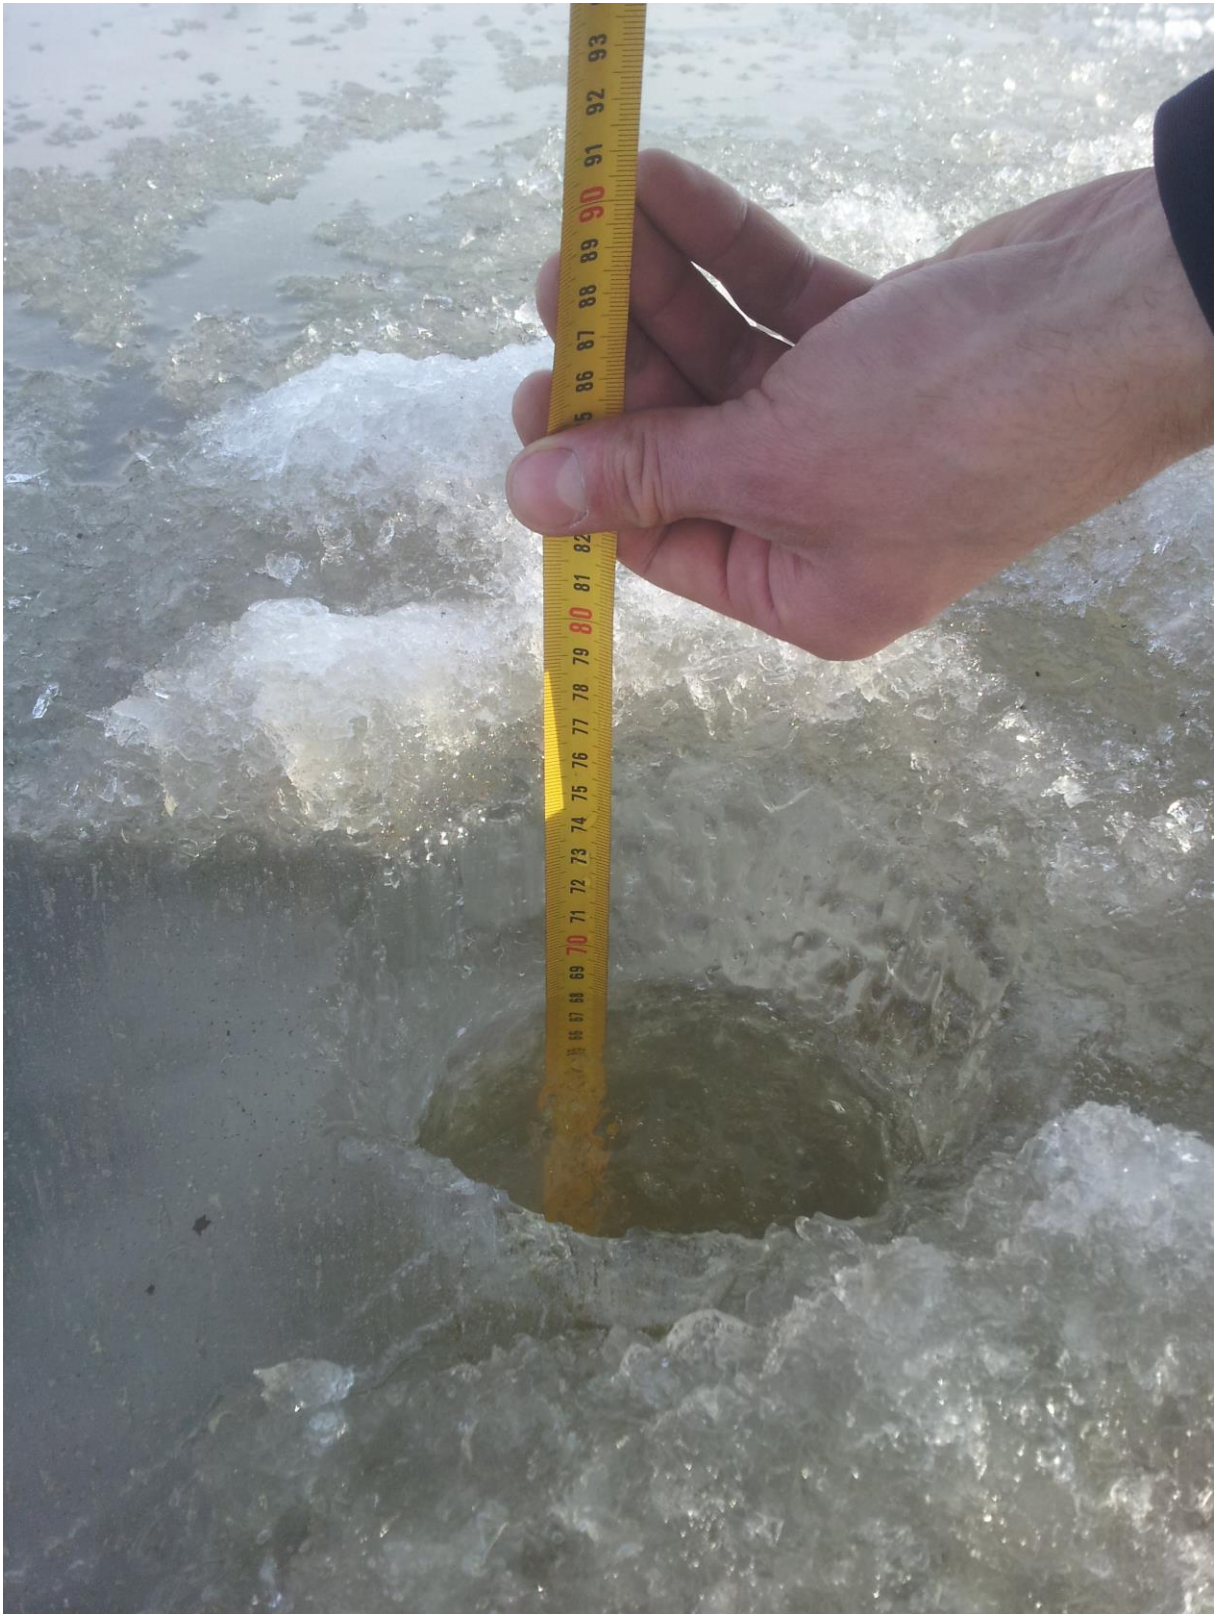
Point 4. thickness 74cm (ridged ice layered on top of each other)

Pic 5. Ice thickness at point 4.

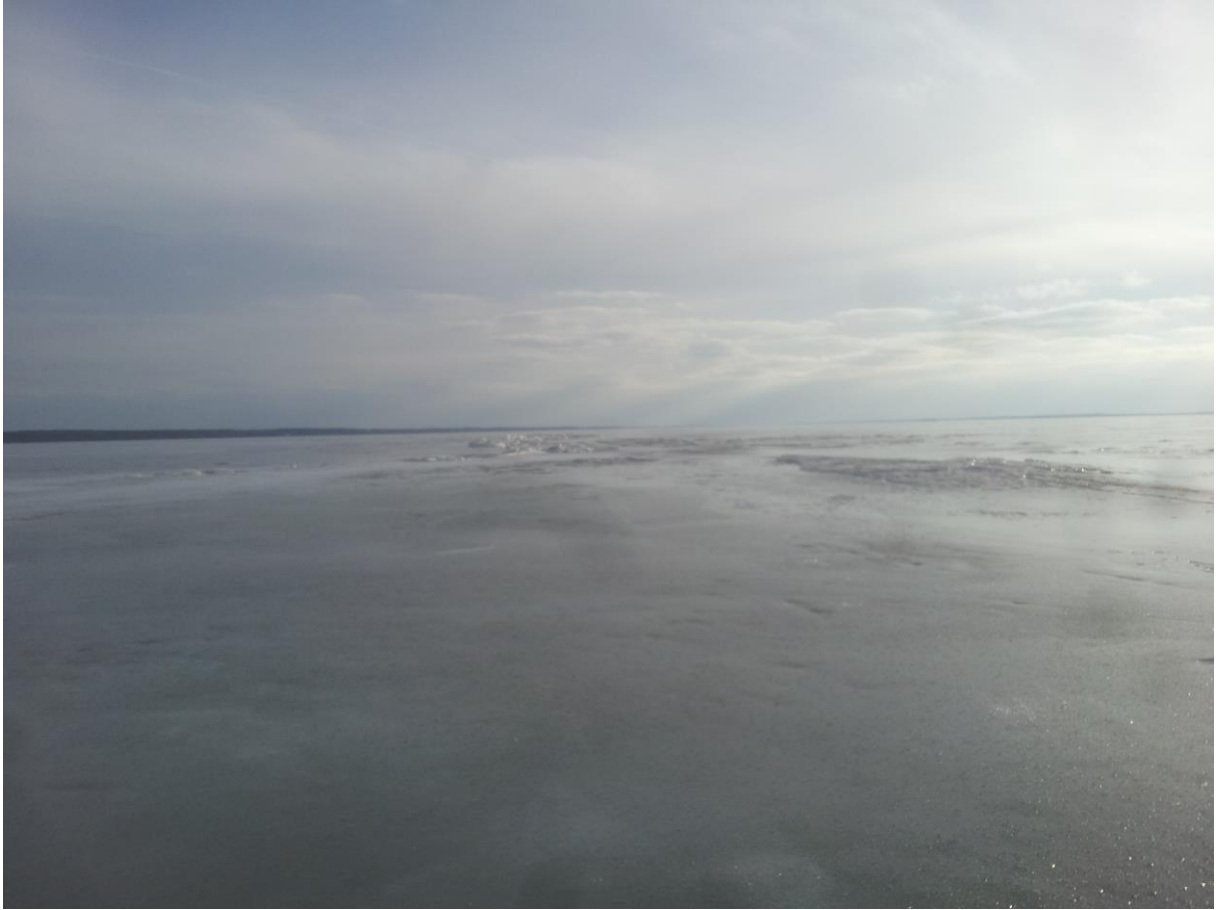
Pic 6. Ridged ice at point 4 (about 50mx50m)

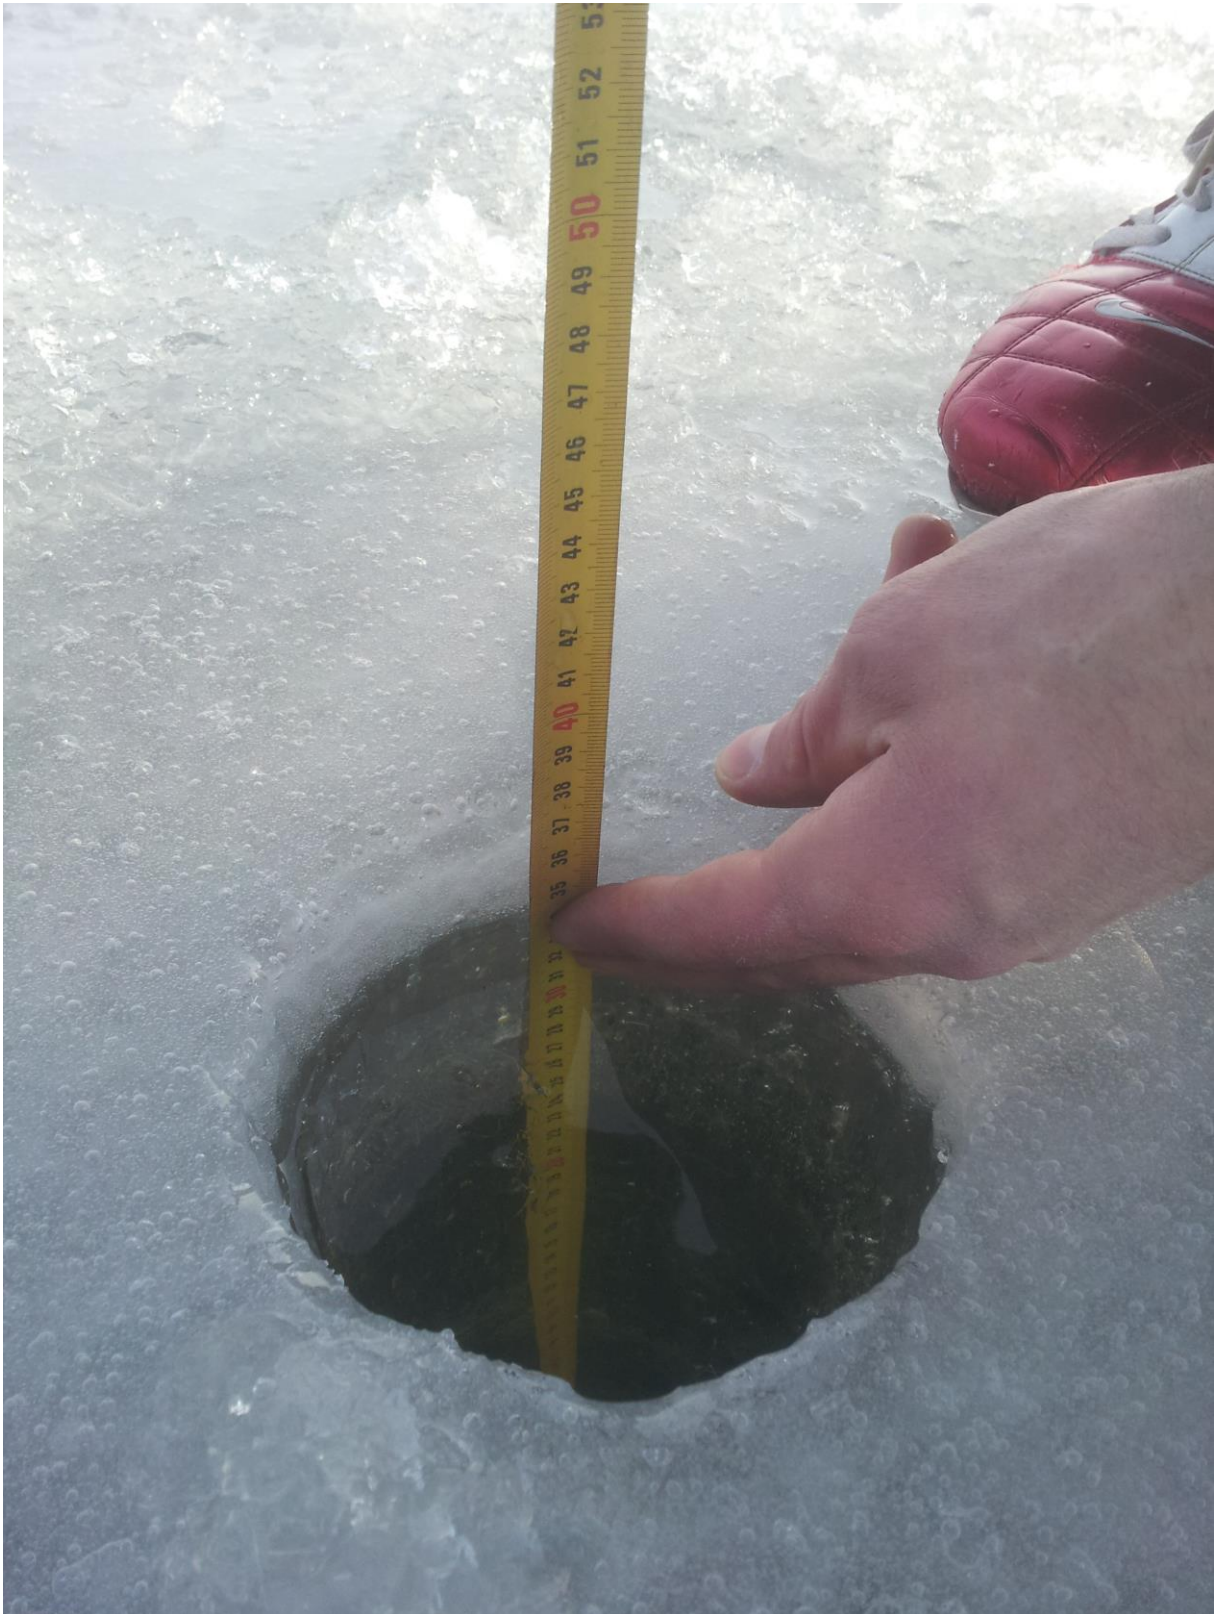
Point 6. thickness 37cm

Pic 7. ice thickness at point 6

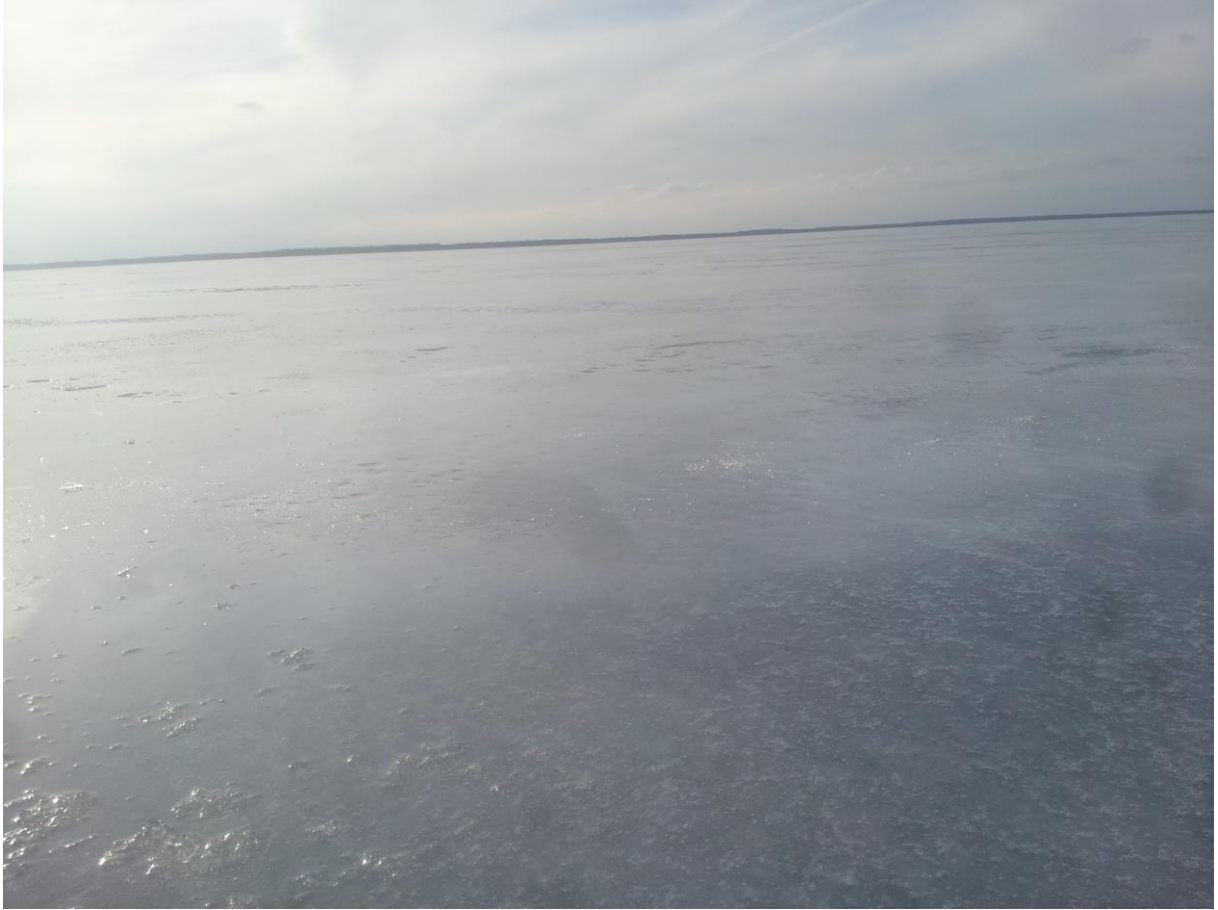
Pic 8. ice overview at point 6.

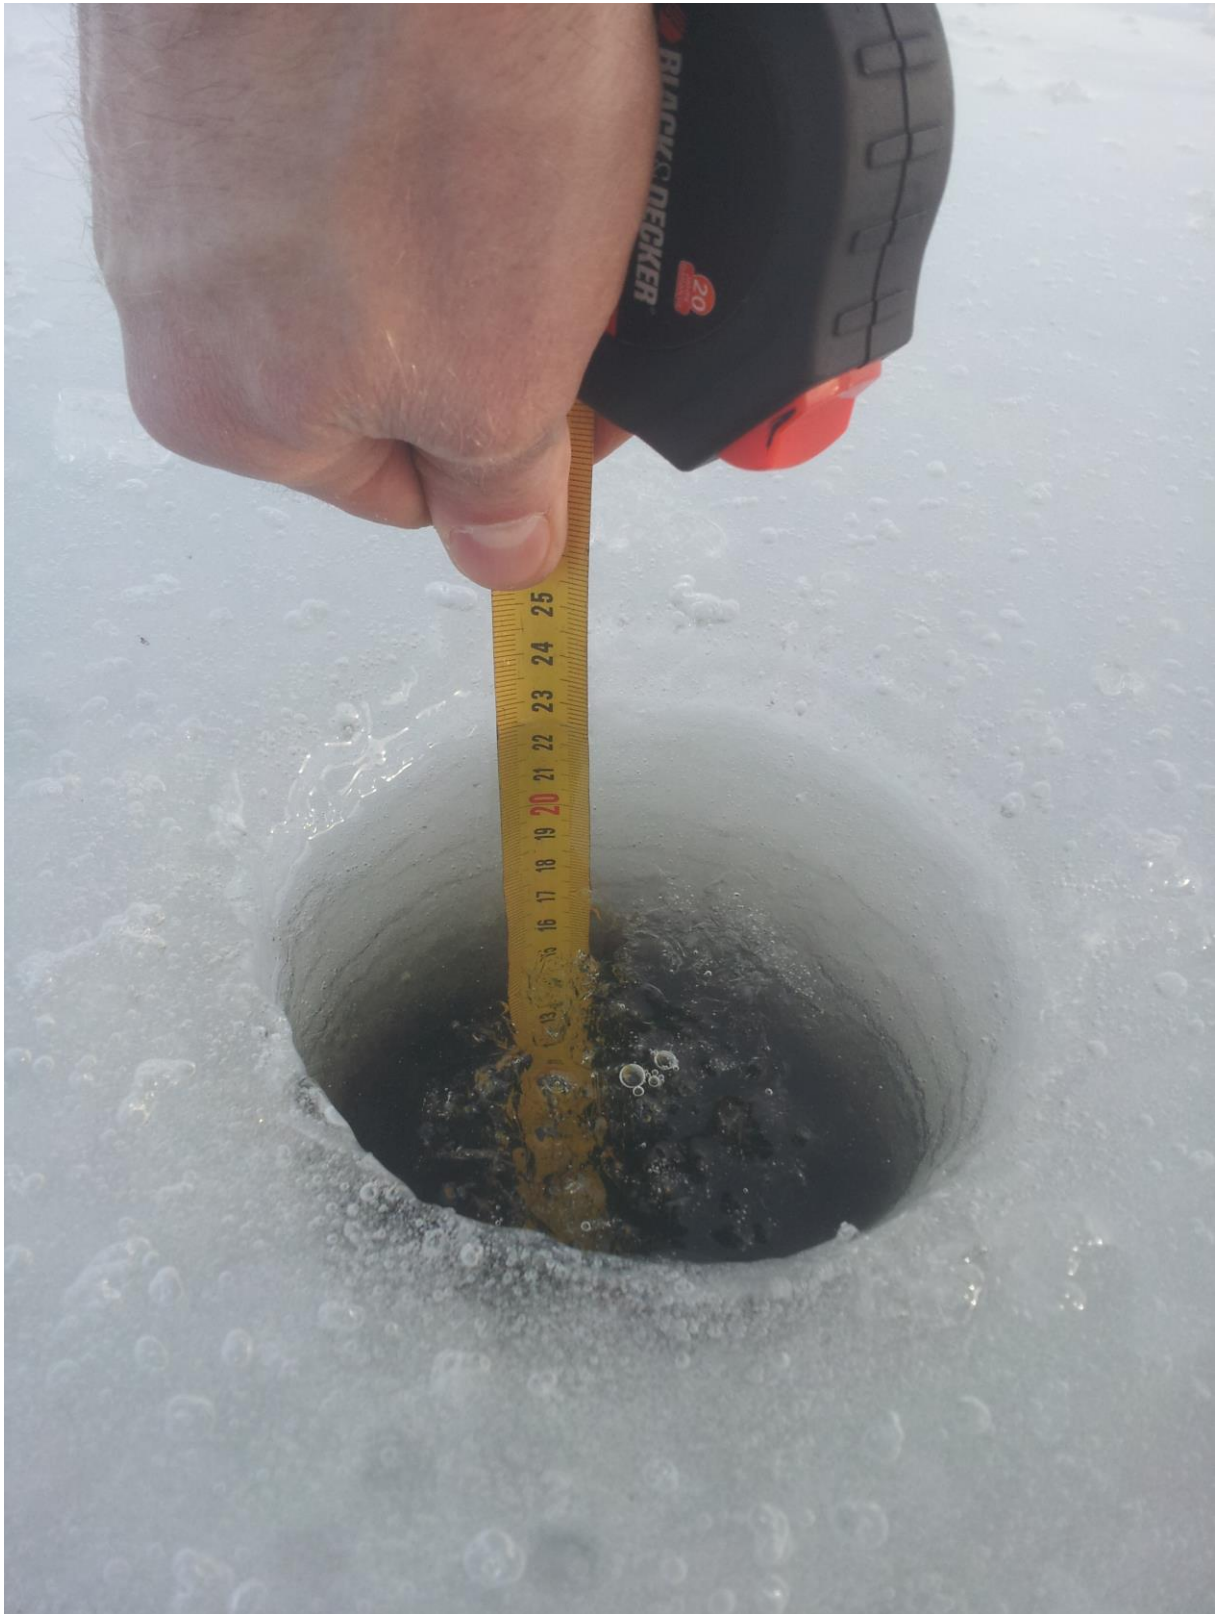
Point 13. thickness 23cm

Pic 9. Ice thickness at point 13.

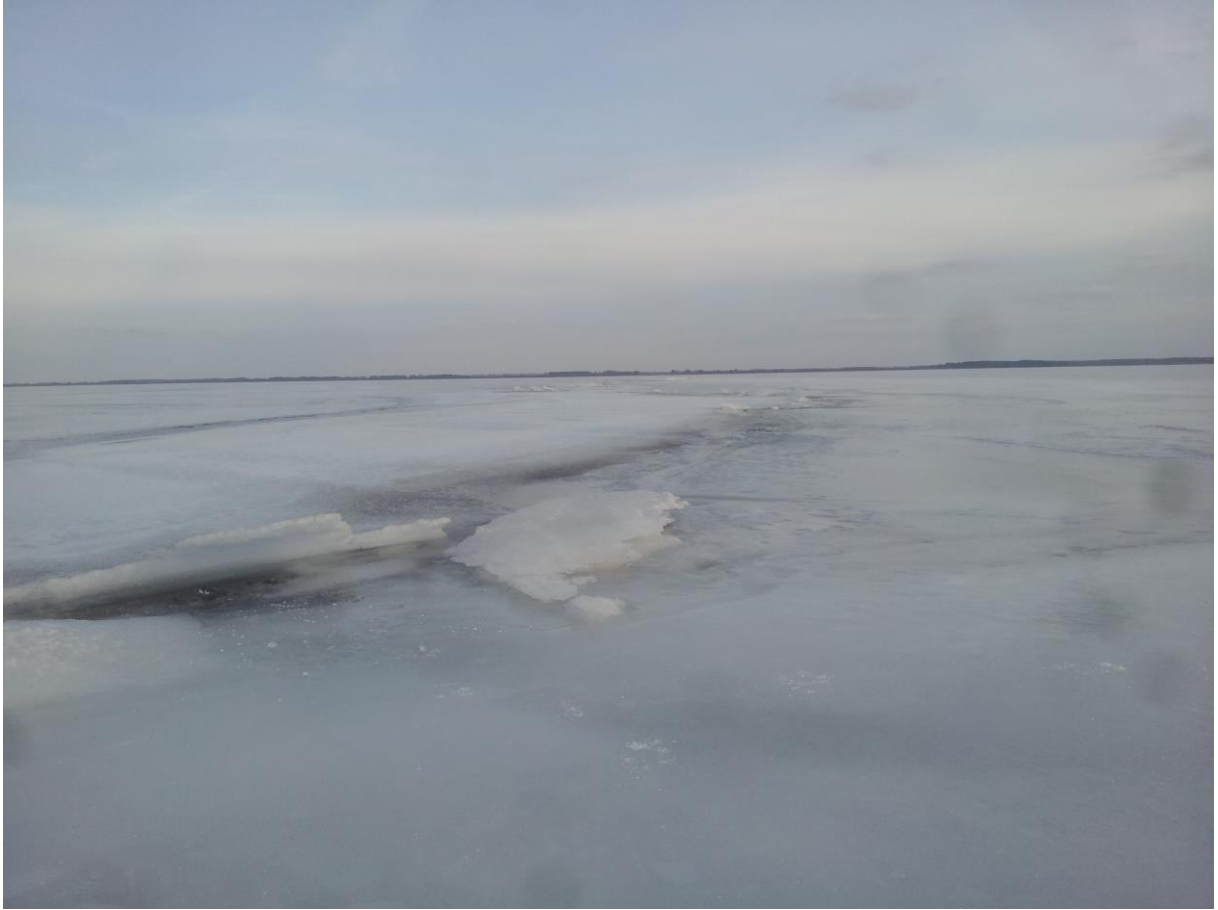
Pic 10. Ridgec ice at point 13.

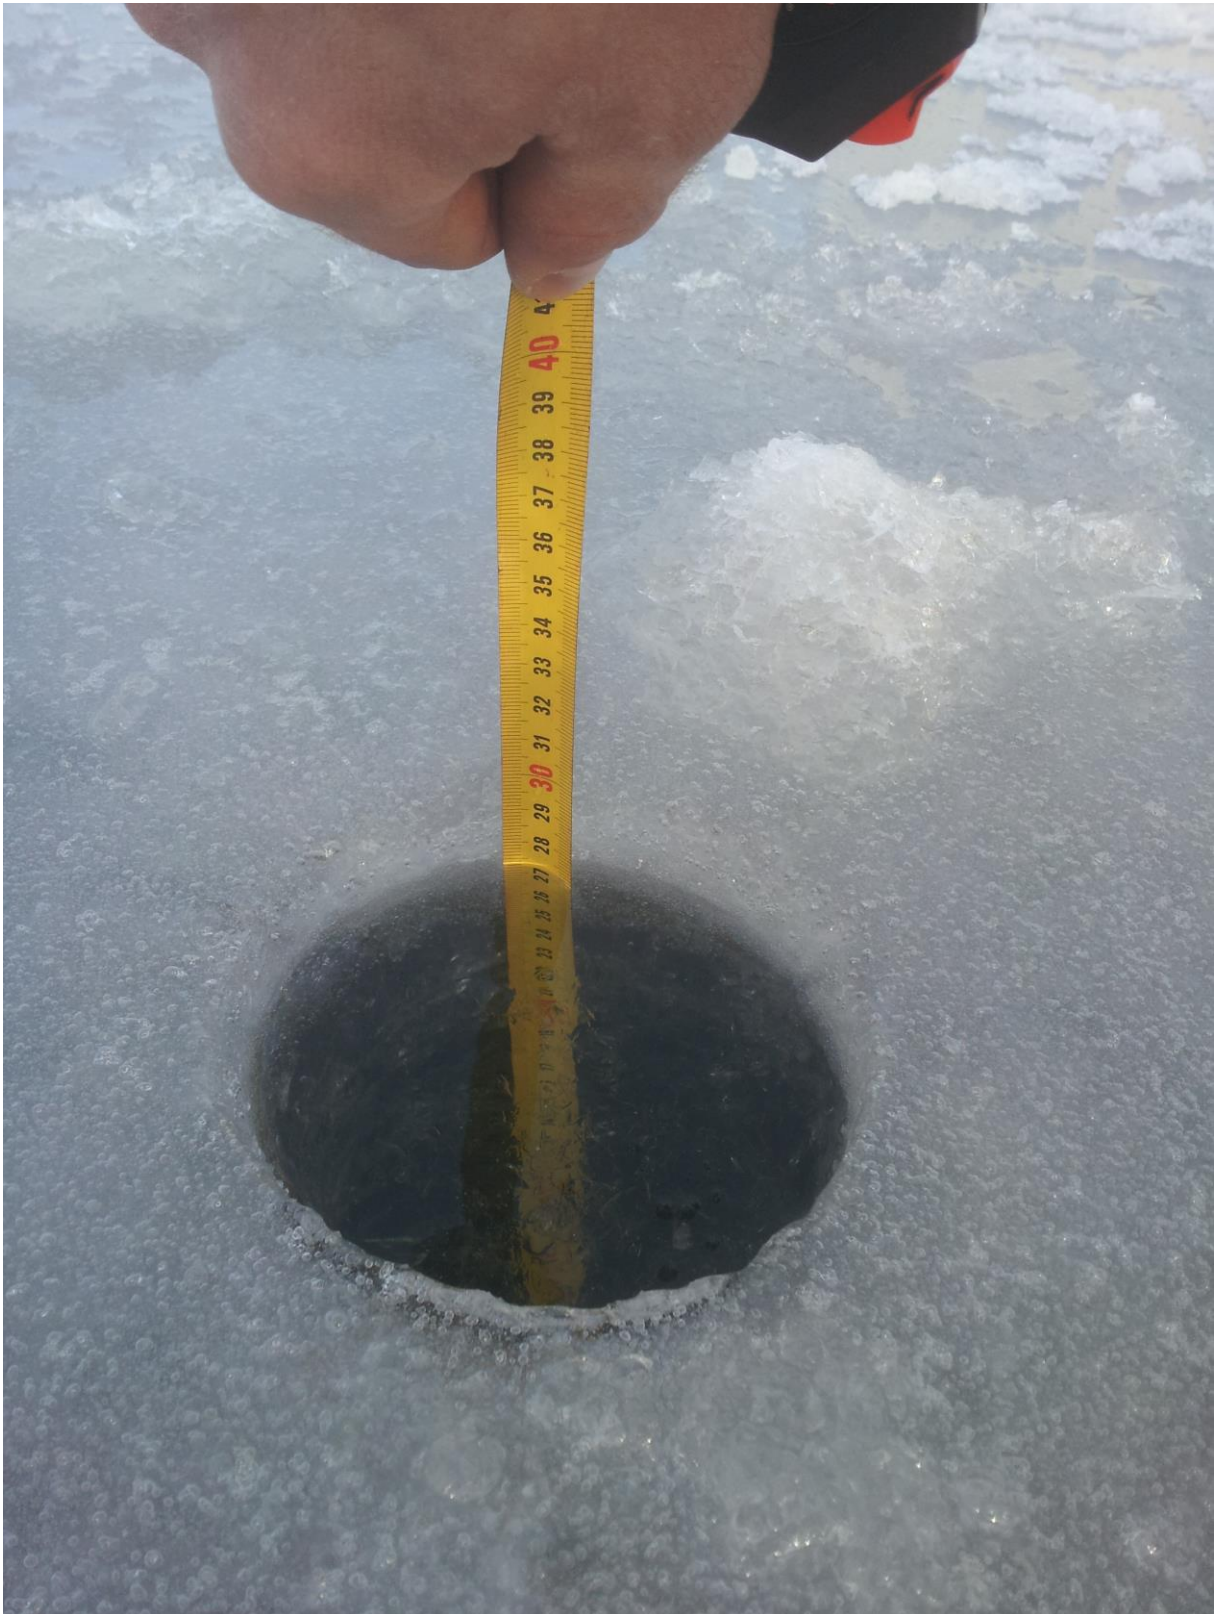
Point 18. thickness 28cm

Pic 11. Ice thickness at point 18

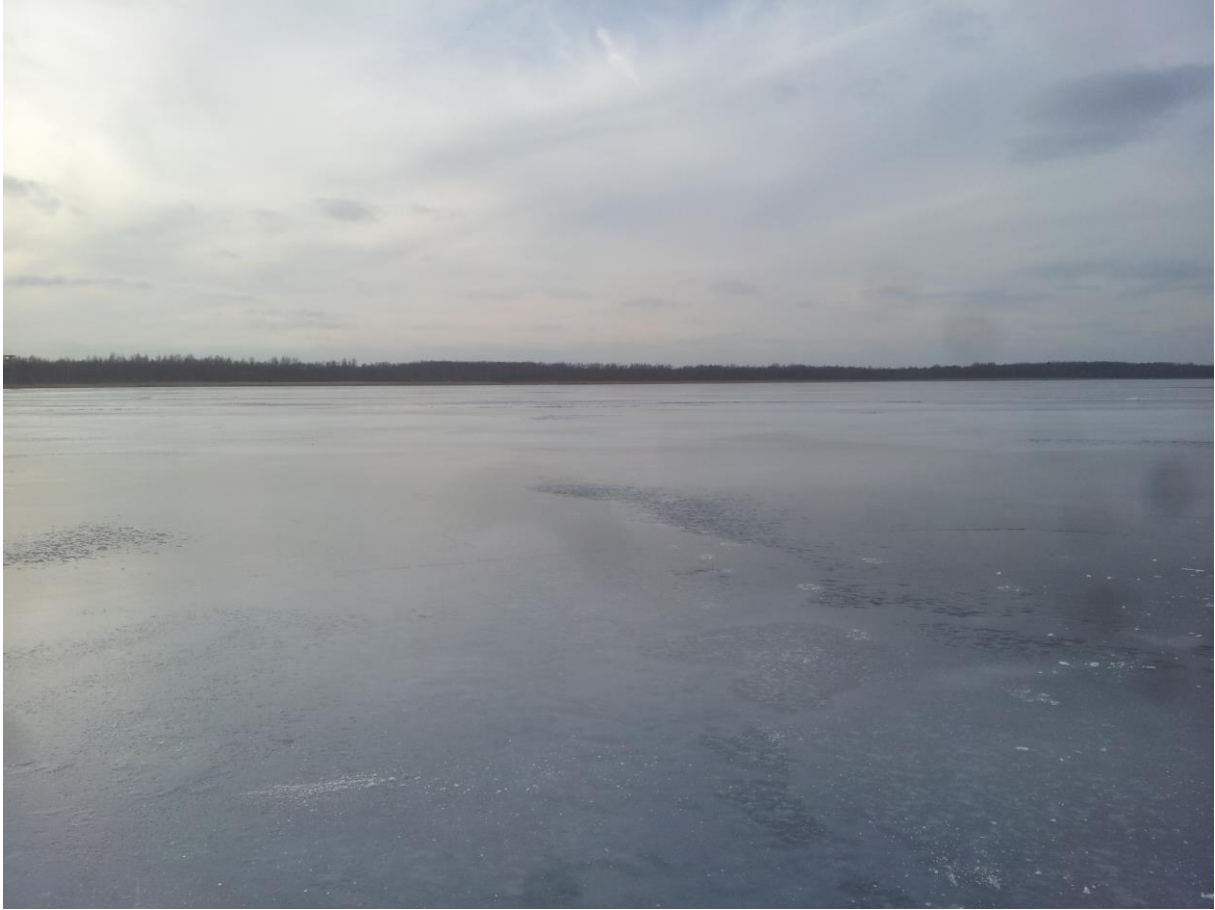
Pic 12. Ice overview at point 18

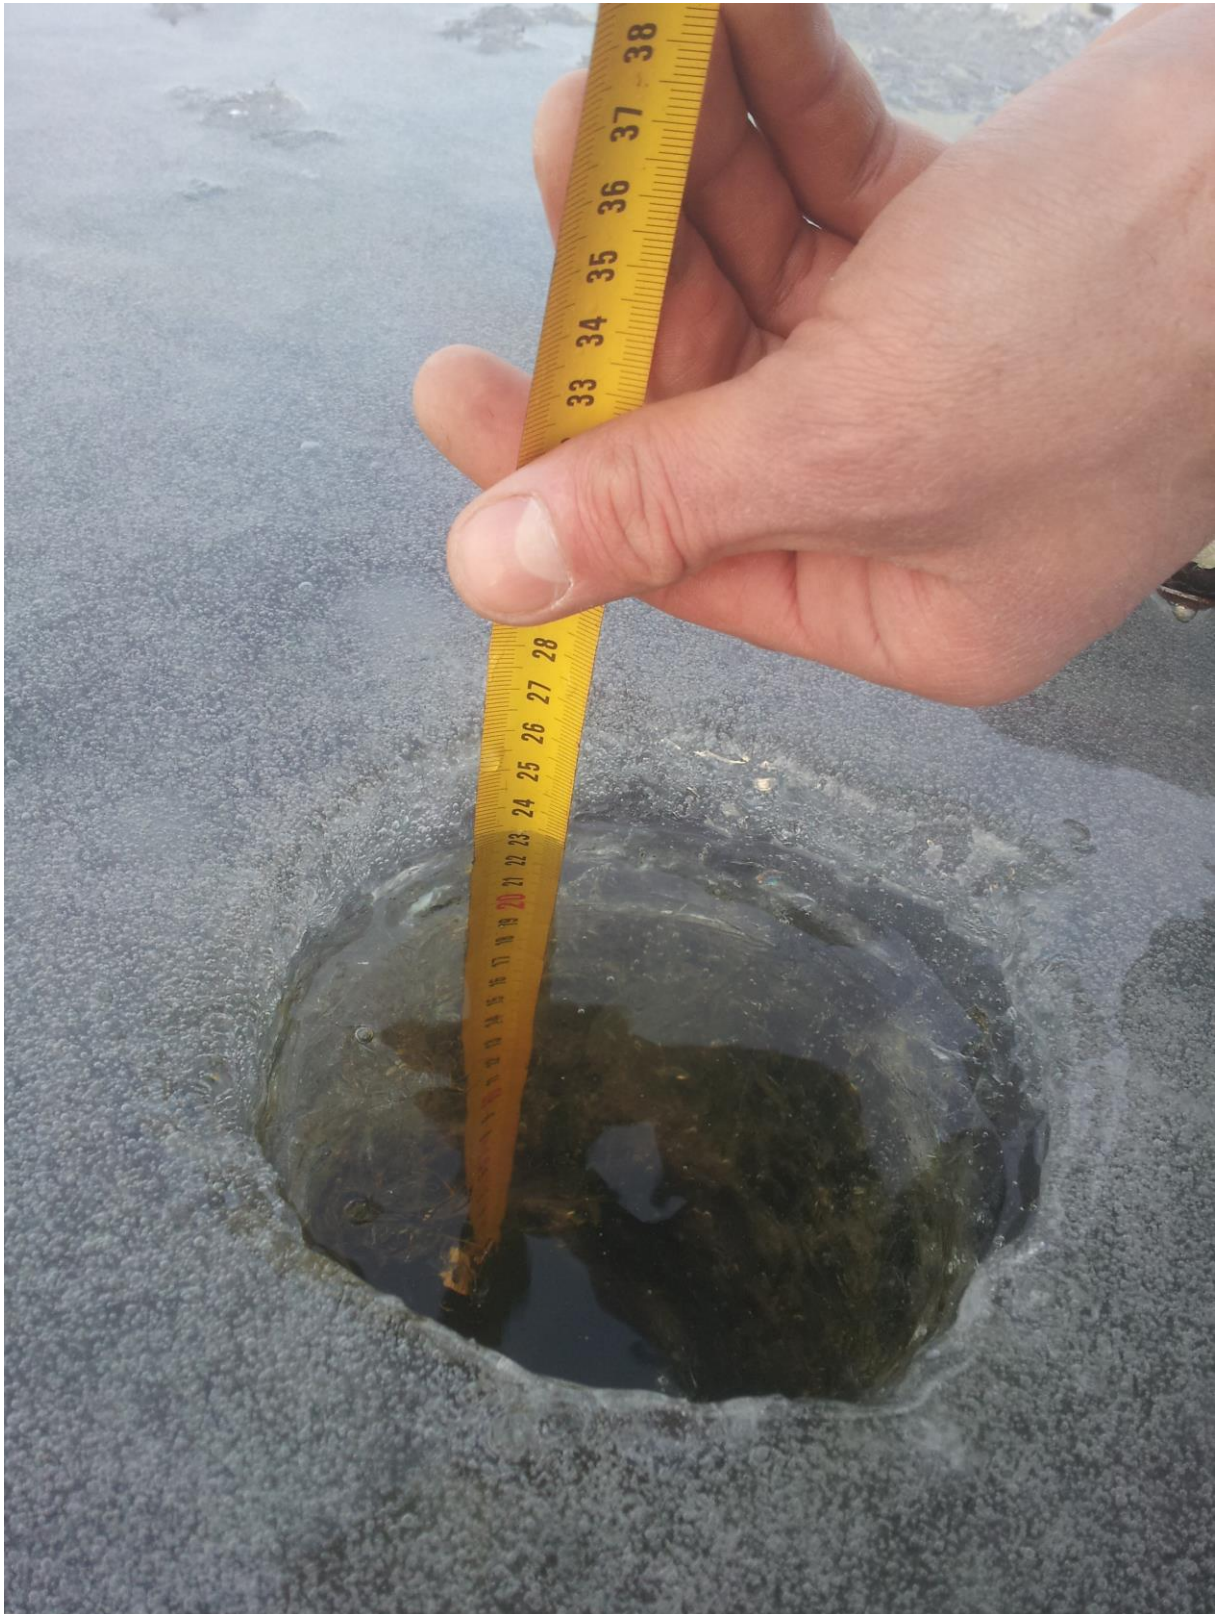
Point 22. thickness 26cm

Pic 13. Ice thickness at pint 22
