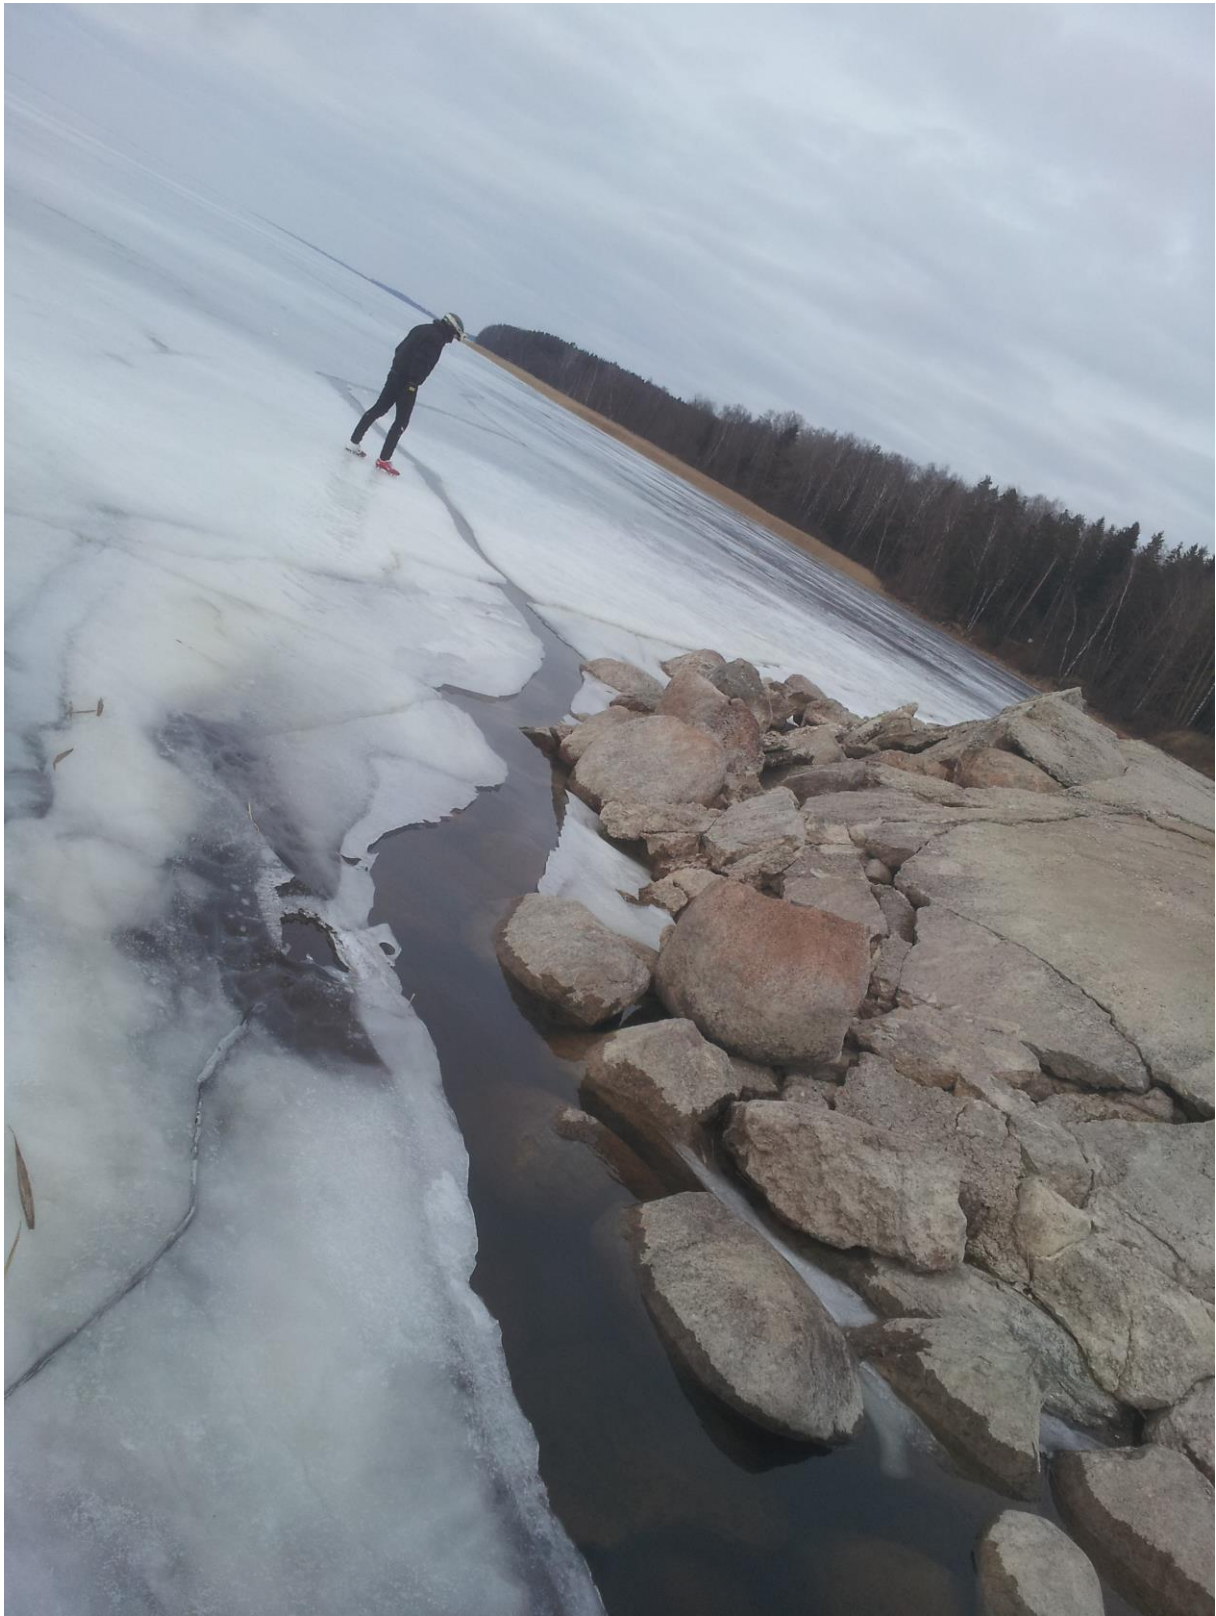
Pic 14. Jetty at Limnoliigia jaam (crack ends in about 100m)

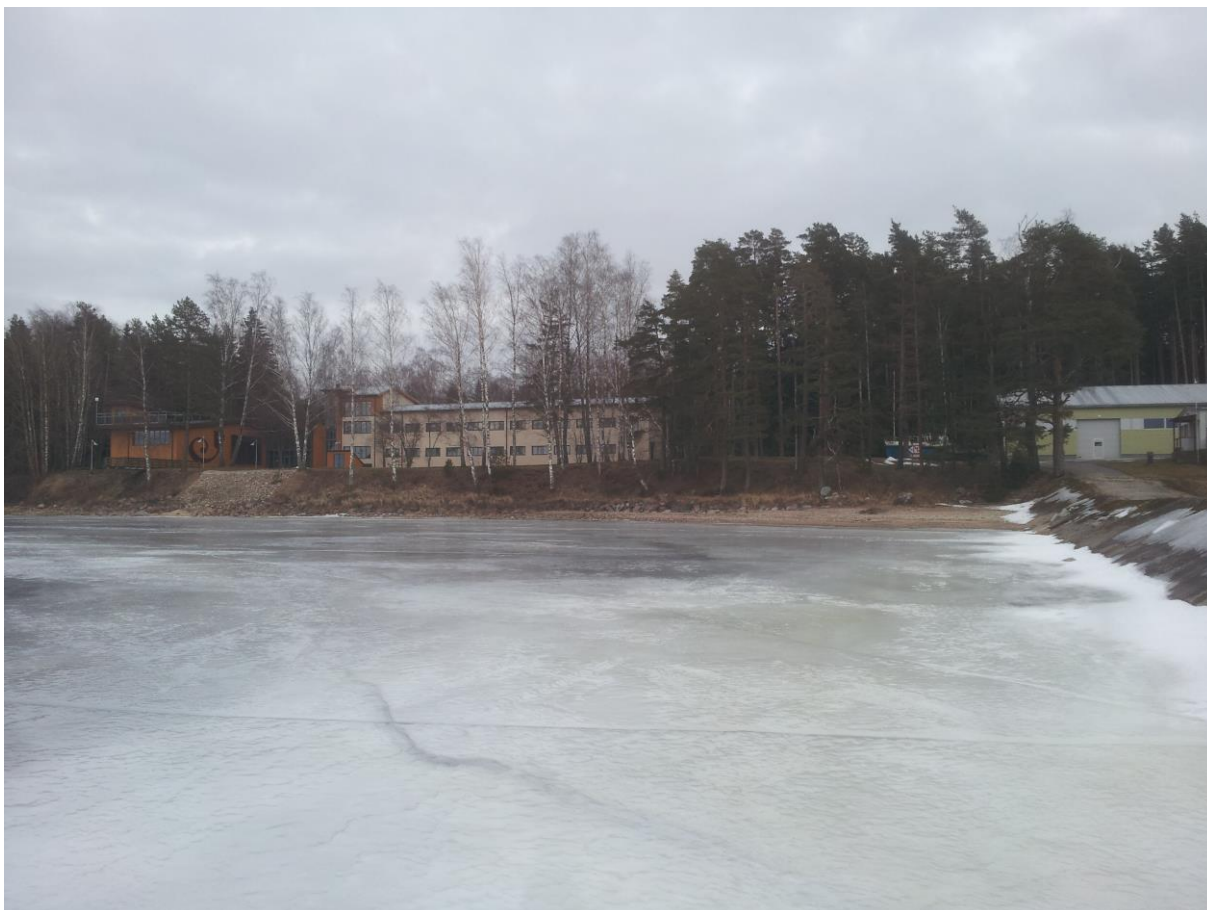
pic 16. ice overview at Limnoloogia jaam
